Fracture, Fatigue and Failure of Materials
Professor Indrani Sen
Department of Metallurgical and Materials Engineering
Indian Institute of Technology, Kharagpur
Lecture 56
Failure Analysis- Case study- Point Pleasant Bridge

Failure Analysis - Stress Corrosion Cracking Failure of Silver Bridge

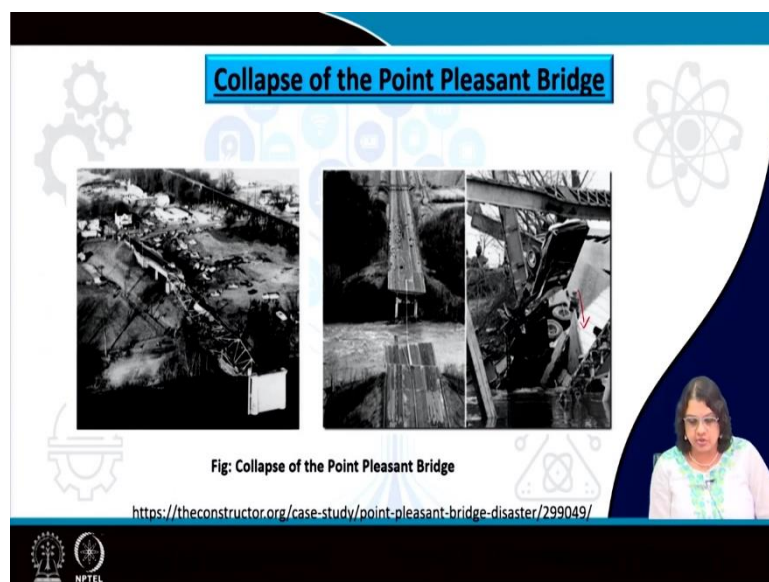
So, you can see the images here and how the cars have been pulled into the water or recovered later on after the incident. And these are the images that were taken by the journalist or the photographers at that time itself.

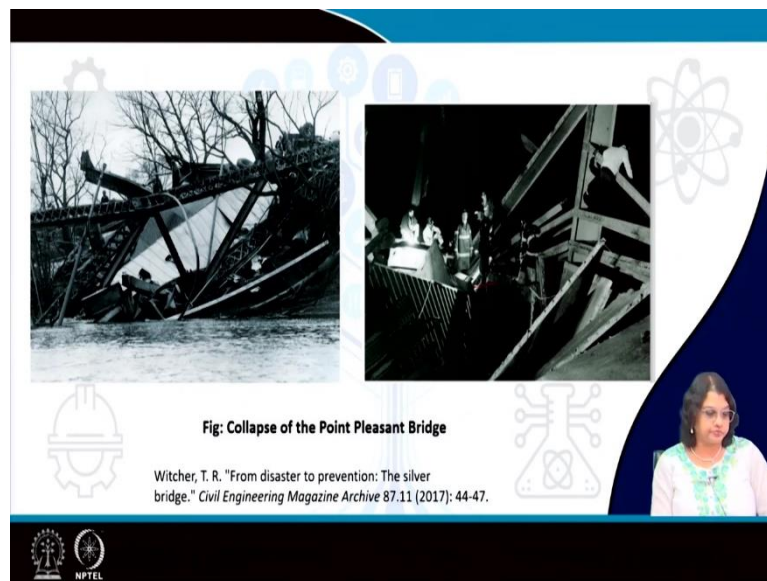
And then there were some rectification works also that went along some failure analysis also has been done and the pictures are taken during those periods. Just to show you that the kind of incident that has happened and in such a giant bridge. If that collapse, all of a sudden will be a really memorable incident. And there are once again if you go to the various websites that are available, you can understand how people have reacted to that there were many survivors of the incident who have seen others drowned and they could somehow recover from there. So, that was a really shocking incident for them.

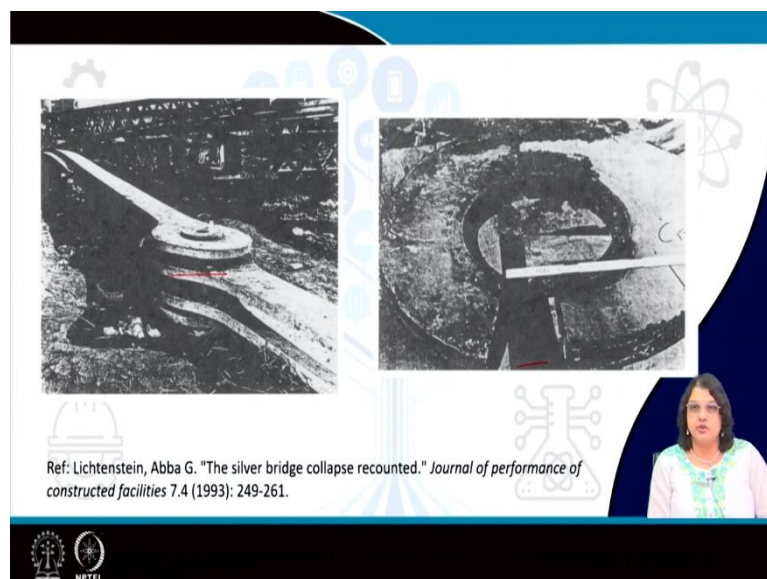
And once again that entire such a huge structure has been very thoroughly examined after the failure, after the collapse to find out what could be the reason and these were the eyebars that

has been recovered. And then one particular eyebar been also pinpointed, which was expected to be the actual reason for the failure.
