Fracture, Fatigue and Failure of Materials
Professor Indrani Sen
Department of Metallurgical and Materials Engineering
Indian Institute of Technology, Kharagpur
Lecture 57
Failure Analysis- Case Study- Rail Crash

Hello everyone, welcome back to the 57th lecture of the course Fracture Fatigue and Failure of Materials. And in this module on failure, we are going to discuss about the case studies on rail crash.

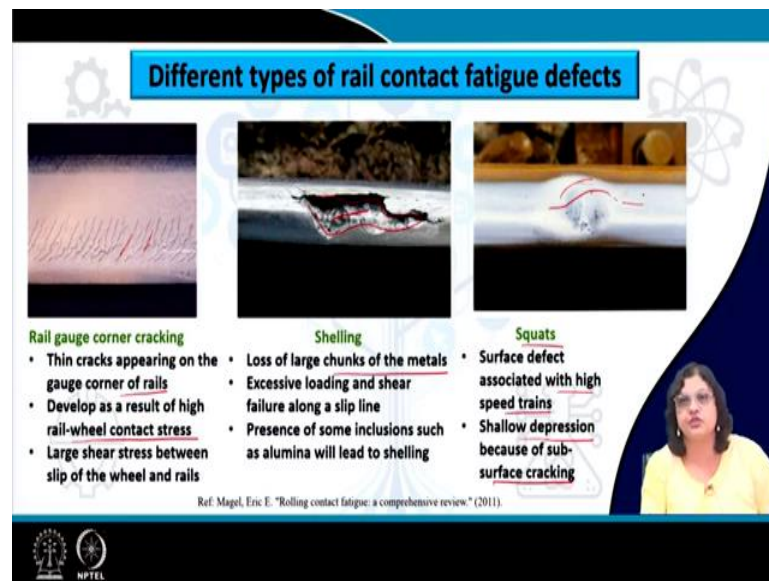
So, here are again the different types of rail contact fatigue defects that may occur. Rail gauge corner cracking, you can see the cracks that are developing here the thin cracks appearing on the gauge corner of rails and this typically develop as a result of high rail to real contact stress. Large shear stress between the slip of the wheels and rails. They can be shelling also as you can see, the material can get chipped off from the structure and this kind of large chunks of metals are coming out and certainly if such kind of irregularity are formed on the tracks.
