Fracture, Fatigue and Failures of Materials
Professor Indrani Sen
Department of Metallurgical and Material Engineering
Indian Institute of Technology, Kharagpur
Lecture 58
Failure Analysis – Case Study – Comet

Case study: Comet failure

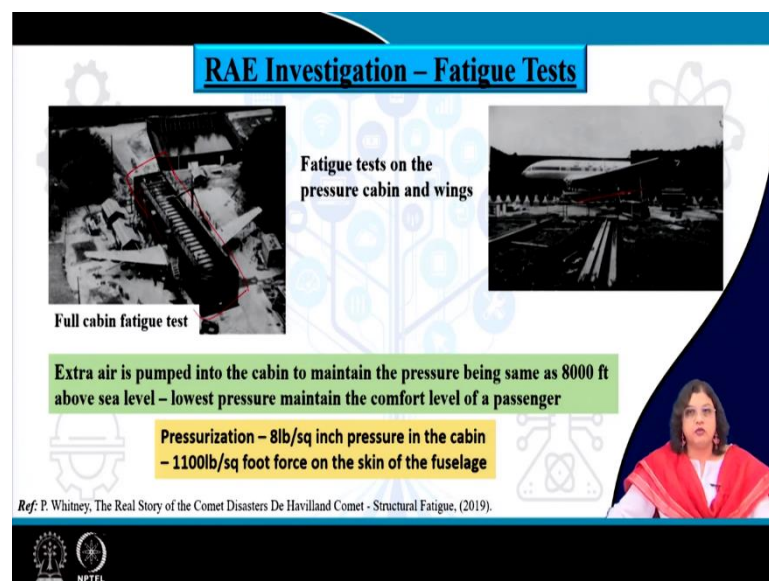
So, fatigue test on the pressure came in and wings were initially done at the very first place. So, you can see that this is an entire aircraft which is under testing for the wing so in this picture you can see that the wings are under testing and this one is for the full cabin fatigue test. So, the entire cabin has been enclosed in some structure to perform the fatigue test of this.

- Aircraft is put in a water tank and pressurized with water
- All internal cabin fixtures were removed and replaced with weights
- Water used to prevent explosive decompression
- Once the elastic energy of the skin is dissipated in the surrounding water tank, rupture will stop – catastrophic explosion can be prevented
- Damaged aircraft skin can be thoroughly investigated for failure analysis

And the aircraft is also put in a water tank and pressurized with water, so another effort, this is the way by which the aircraft is put in a water tank and pressurized with water all the internal cabin fixtures were removed and replaced with weights and water is used to prevent the explosive decompression.

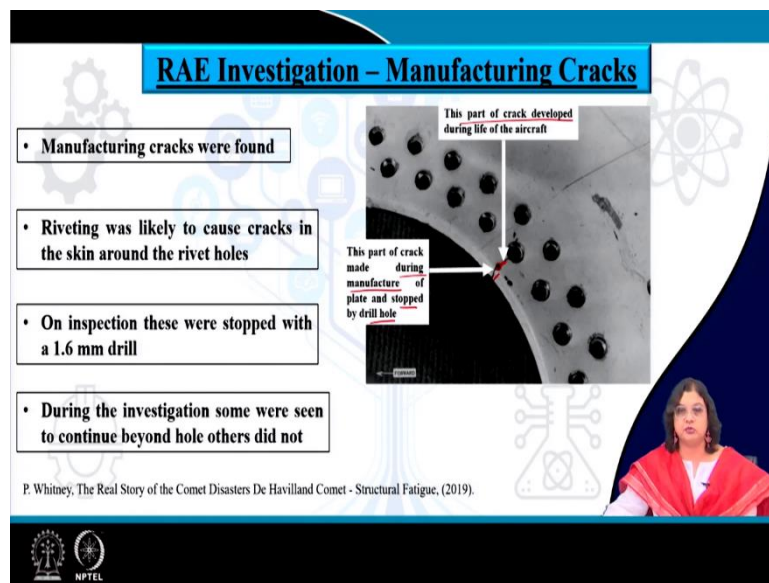
- Manufacturing cracks were found
- Riveting was likely to cause cracks in the skin around the rivet holes
- On inspection these were stopped with a 1.6 mm drill
- During the investigation some were seen to continue beyond hole others did not

This part of crack developed during life of the aircraft

This part of crack made during manufacture of plate and stopped by drill hole

And what they could understand from the detailed study is that, so some part of the hole that has been punched that lead to formation of a crack during the manufacturing process itself and that could have been stopped by drilling a hole. However, you can see that this part of the crack developed during the life of the aircraft.

So, if there is any kind of manufacturing defect already existing and then with the repeated pressurization and depressurization that kind of crack is bound to expand or increase in length as per the fatigue and that may lead to the failure of the entire aircraft. So, this manufacturing defects were located and noted and riveting was likely to cause cracks in the skin around the rivet holes that were found and an inspection this was topped with a 1.6 millimetre drill as you can see here.

However, during the investigation some were seen to continue beyond the hole while some others, do not. So, we never know that how these defects will actually behave in presence of repeated pressurization and depressurization but certainly such defects are the source from which the crack might have initiated and led to the catastrophic failure.

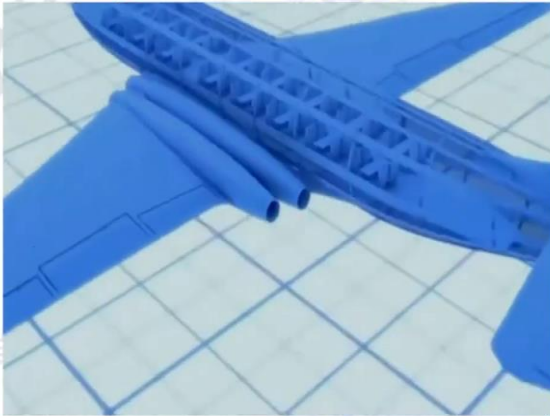
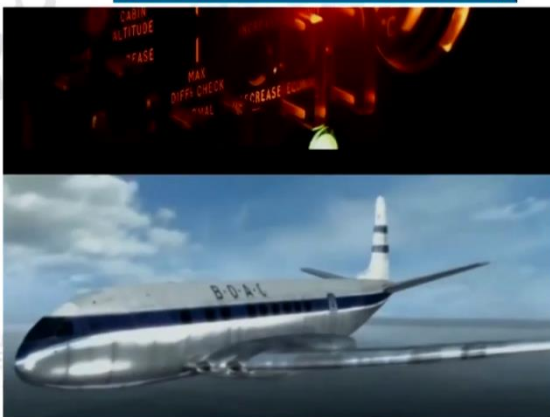
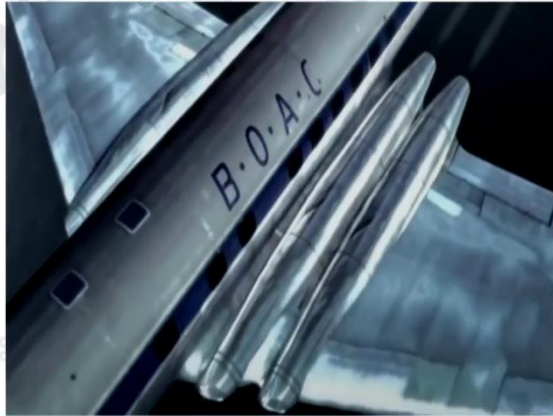
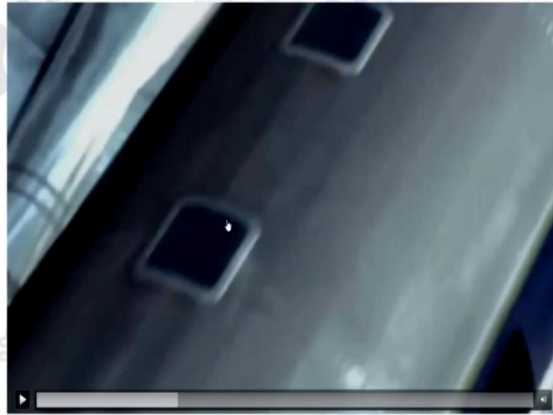
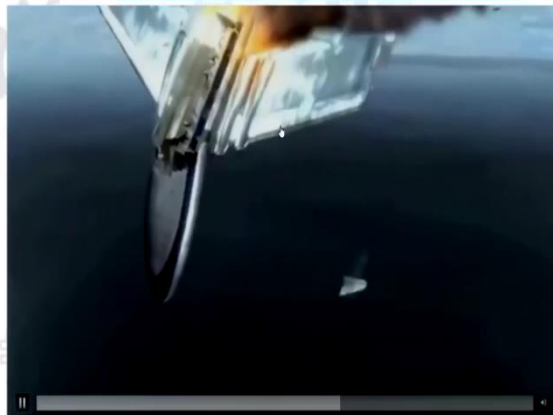
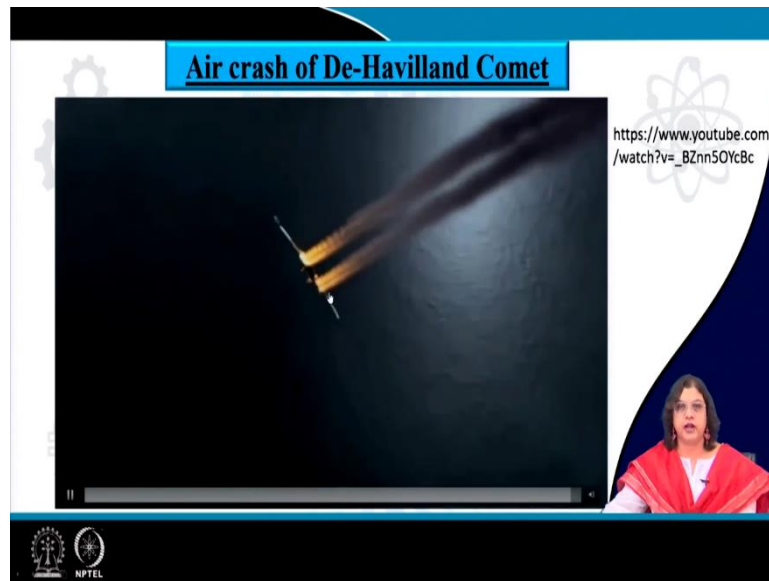
Air crash of De-Havilland Comet

So, this can be well understood from these videos, you can see that these are again the simulated videos and the thin aluminium skin which is really really very thin just to have pressure saving and you can see that the rivet while punching may form some defects there.

Now there are repeated pressurization and depressurization as we have discussed and with this the cracks are bound to get extended and it has been again simulated that how the failure has happened and of course the defects if propagated may lead to fractures.

So, if we look into this structure you have to carefully note about these windows and you will see that how the fracture has actually happened or started from this part. We have also seen this from the wreckage that they have recovered these windows are the one that has been recovered and all the stress analysis has been done on these corners.

So, let us look into this the crack has been expanded and you can see the mid portion is the one that has been initially flown off and then the tail one and finally the entire aircraft has already crashed and fell down into the sea.

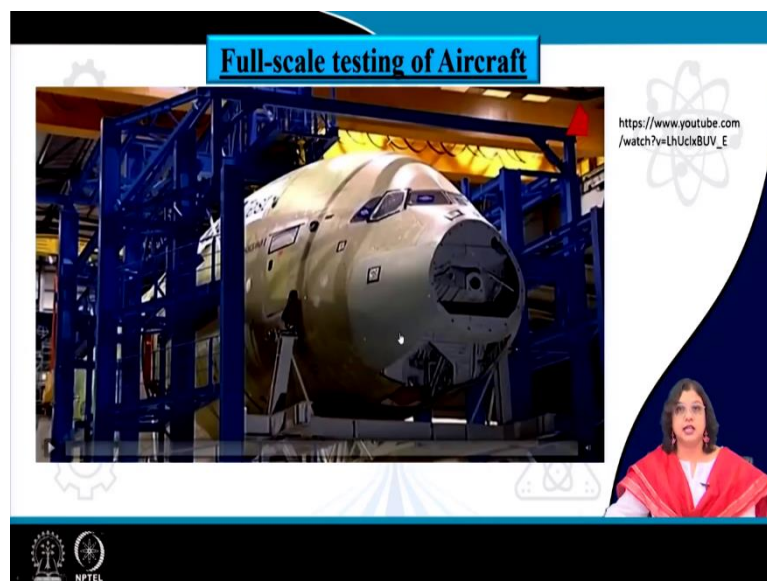
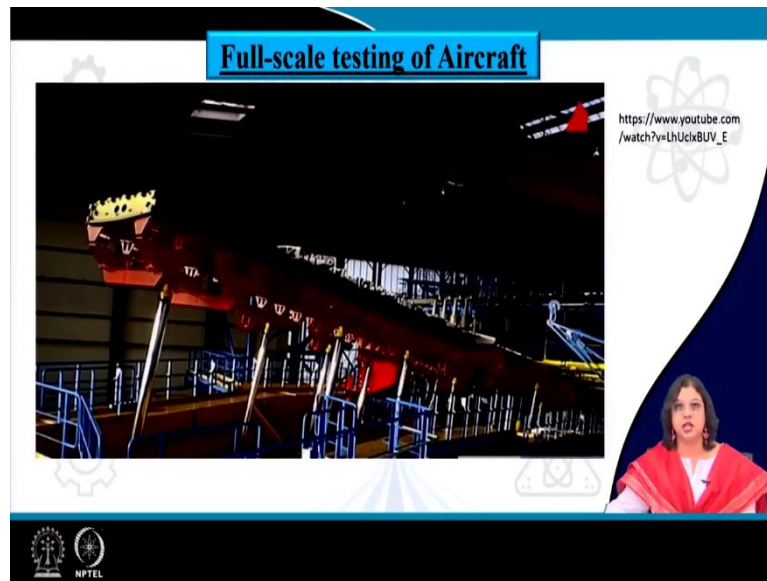
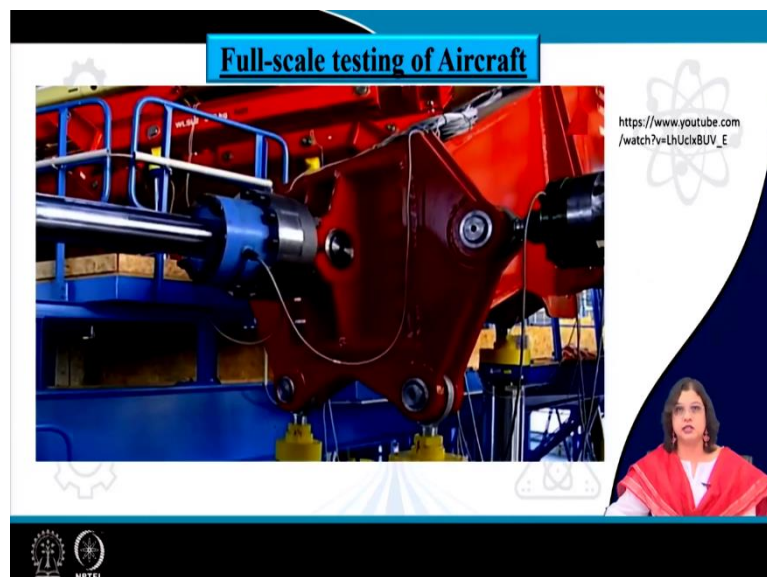
So, let us see here what I mean, you can see here that a full aircraft a total aircraft one is being tested for fatigue and all the parts, the wings and the fuselage and the engine parts and all the different parts are being tested in the service condition to understand whether it is capable of performing at those particular conditions and if it is so then for how long, for how many cycles or how many flights can be covered by this kind of aircraft.
