**Fracture, Fatigue and Failures of Materials**  
**Professor Indrani Sen**  
**Department of Metallurgical and Material Engineering**  
**Indian Institute of Technology Kharagpur**  
**Lecture 59**  
**Failure Analysis – Case Study – Columbia**

## Space Shuttle Columbia

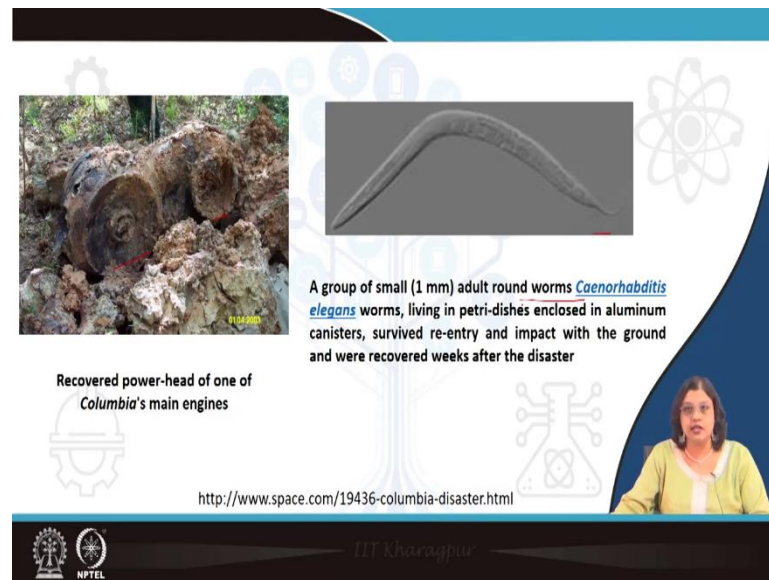
Recovered power-head of one of Columbia's main engines

A group of small (1 mm) adult round worms *Caenorhabditis elegans* worms, living in petri-dishes enclosed in aluminum canisters, survived re-entry and impact with the ground and were recovered weeks after the disaster

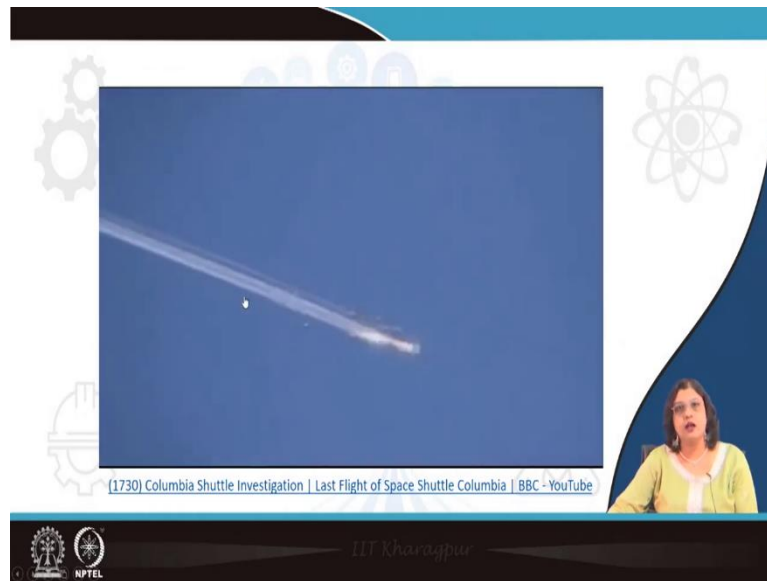
So, here is a video to understand what actually might have happened so you can see that the launching was quite good and it appeared very very successful launching and that was the pilot Rick Husband and you can see the foam coming out and striking the left wing very clearly.

Now this has been repeated in the simulation for you to understand more and you can see the same frame was actually being shown that how it is, so this part is a simulation one. To understand that what kind of force it might have generated, how much the damage are there and what is the size of the hole that has been formed that has been very very carefully analysed and determined and experimentally validated as well.

So, this has been shown from different angles for you to understand that what is actually the impact of the foam falling on the left wing of the aircraft. So, the spacecraft however has performed all it is intended to do and everything looked quite successful up to that level and nobody was actually aware that something has happened to the structure and now you can see that the point the time at which it was supposed to land, at that point there are has been just some fragments which has been noted on the skyline.
