**Fracture, Fatigue and Failure of Materials**  
**Professor Indrani Sen**  
**Department of Metallurgical and Materials Engineering**  
**Indian Institute of Technology, Kharagpur**  
**Lecture 54**  
**Failure Analysis-case Study-Titanic**

**Case Study: Titanic**

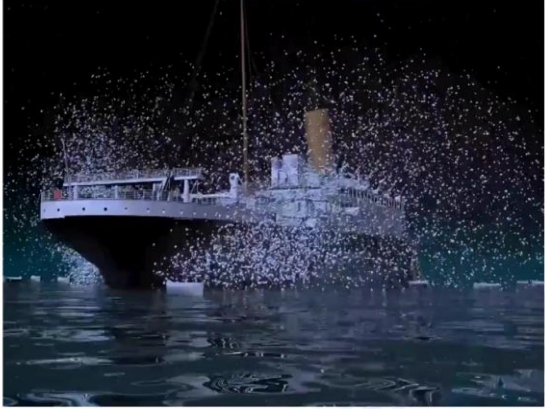
2.20 a.m., April 15, 1912: Titanic sank

**Loss of lives ~ 1500**

And this actually struck the ship near the hull 4 meter above the keel, those are the points of contact that has happened. And in next 10 seconds just within 10 seconds of the collision. 100 meter of hull plates got damaged and rivets are popping out which led the first five of the 16 watertight compartments got opened up. So, you remember when I said that there were 16 watertight compartments that were meant to make the Titanic unsinkable. However, out of that five got damaged and the rivets pop out and the hull plates got open, which means the water can right away gush in and that is what has happened.

Although within the ship, including the passengers and crew members, there were almost 2200 people. So, lifeboats were sufficient only for up to 50 percent of the people on the ship. But however, the initially launched, lifeboats were only 60 percent full so they have not even launched the lifeboats with the full capacity. And there are several reasons for that, which are being discussed or which have been shown in the movie also, and nothing to do with the metallurgical factors as such. But what we can see here is that how the ship has actually broken apart into 2 pieces, as if this is just like a toy. And it sank finally at around 2:20am on April 15th. And we know that there was around loss of lives of 1500 people, which could not survive.

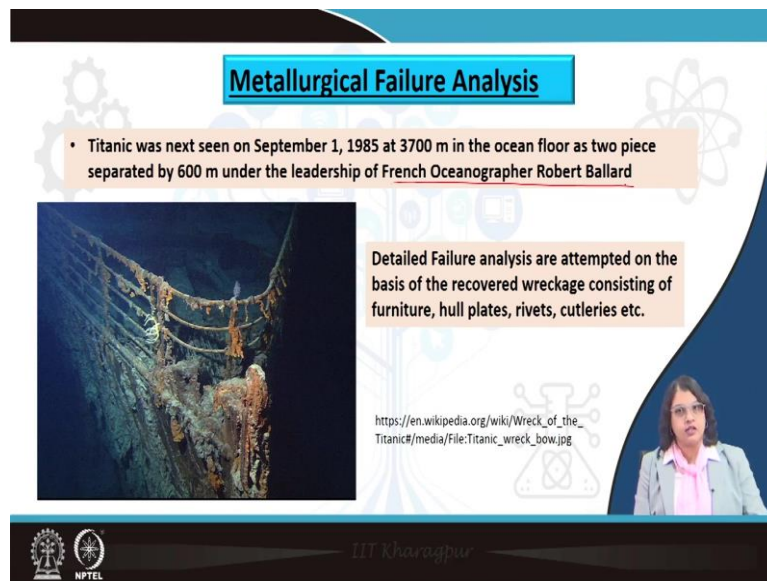
The slide is titled "Metallurgical Failure Analysis" in a blue box. It features a central image of the Titanic's bow, heavily encrusted with rusticles. To the right of the image is a text box stating: "Detailed Failure analysis are attempted on the basis of the recovered wreckage consisting of furniture, hull plates, rivets, cutleries etc." Below this text is a URL: [https://en.wikipedia.org/wiki/Wreck\\_of\\_the\\_Titanic#/media/File:Titanic\\_wreck\\_bow.jpg](https://en.wikipedia.org/wiki/Wreck_of_the_Titanic#/media/File:Titanic_wreck_bow.jpg). A small inset video of a woman is visible in the bottom right corner of the slide. The slide also includes logos for IIT Kharagpur and NPTEL at the bottom.

So, let us look into our part here. So, far all those corrective measures were taken based on the general understanding about what may have went wrong? But the actual reason for the failure can be well understood from the metallurgical failure analysis if we can do that. So, Titanic was next seen the incident happened in 1912. And it was next recovered on 1985 in September 1 of 1985 at around 4 kilometers beneath the sea level, and 2 pieces were separated by 600 meters. And this entire wreckage recovery has been done under the leadership of French oceanographer Robert Ballard. You can see the image here how the entire thing is covered with rusticles.

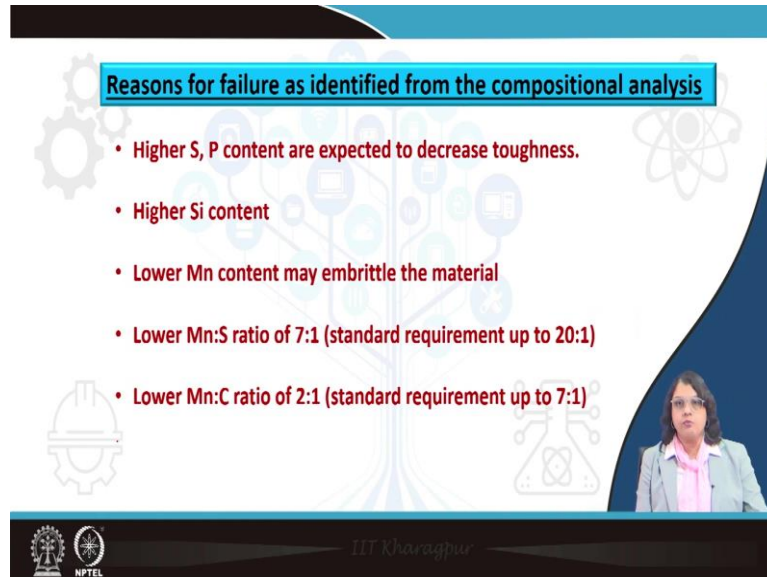
**Reasons for failure as identified from the compositional analysis**

- Higher S, P content are expected to decrease toughness.
- Higher Si content
- Lower Mn content may embrittle the material
- Lower Mn:S ratio of 7:1 (standard requirement up to 20:1)
- Lower Mn:C ratio of 2:1 (standard requirement up to 7:1)

So, if we can understand the failure analysis on the basis of the composition, we can say that the higher sulfur and phosphorus content actually lead to reduction in the toughness. High silicon content is also one of the reasons and lower manganese is expected to embrittle the material, lower manganese to sulfur ratio, lower manganese to carbon ratio are the culprits which actually reduced the toughness had enough manganese sulphide inclusions which might have also led to fracture. So, far this is what we understand from the compositional analysis.

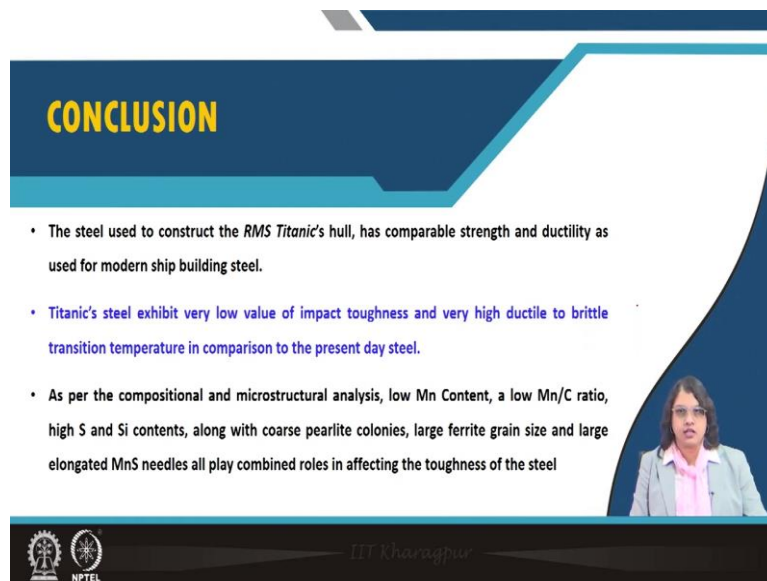
**CONCLUSION**

- The steel used to construct the *RMS Titanic's* hull, has comparable strength and ductility as used for modern ship building steel.
- Titanic's steel exhibit very low value of impact toughness and very high ductile to brittle transition temperature in comparison to the present day steel.
- As per the compositional and microstructural analysis, low Mn Content, a low Mn/C ratio, high S and Si contents, along with coarse pearlite colonies, large ferrite grain size and large elongated MnS needles all play combined roles in affecting the toughness of the steel

- There is evidently a large variation in properties among the plates that made up the hull of *Titanic* as related to the batch process of manufacturing
- High slag contents and presence of coarse stringers leading to anisotropy in mechanical performance are the key factors generating the hole and letting water gushed in and thereby the sinking of *Titanic*.
- Brittle steel plates and rivets are only some factors to the failure event.
- Heat treating the steels to homogenize the microstructure or lower content of the slag content could have acted positively and have avoided the failure. However, this knowledge was not at all available.
