Fracture, Fatigue and Failure of Materials
Professor Indrani Sen
Department of Metallurgical and Materials Engineering
Indian Institute of Technology, Kharagpur
Lecture 56
Failure Analysis- Case study- Point Pleasant Bridge

Failure Analysis - Stress Corrosion Cracking Failure of Silver Bridge

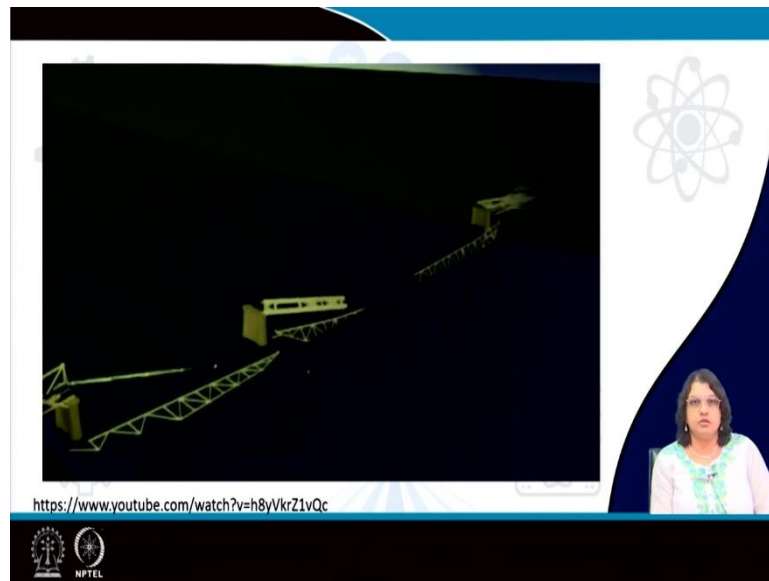
So, here is an example for that. And you can see that this has been already shown that how the eyebar are being fitted here. And now it is capable of moving to some extent, but whenever there is a crack, so, that initiated at one location and that led to the failure of that eyebar and as a result, what you can see is there will be some amount of deformation as well as there was exceedingly high stress. And then the other side of the eyebar also fails and once the one of the chain fails, that leads to the non-uniformity and the stress distribution to the other parts and you can see how the entire bridge just collapse all of a sudden.
