Fracture, Fatigue and Failure of Materials
Professor Indrani Sen
Department of Metallurgical and Materials Engineering
Indian Institute of Technology, Kharagpur
Lecture 57
Failure Analysis- Case Study- Rail Crash

Hello everyone, welcome back to the 57th lecture of the course Fracture Fatigue and Failure of Materials. And in this module on failure, we are going to discuss about the case studies on rail crash.

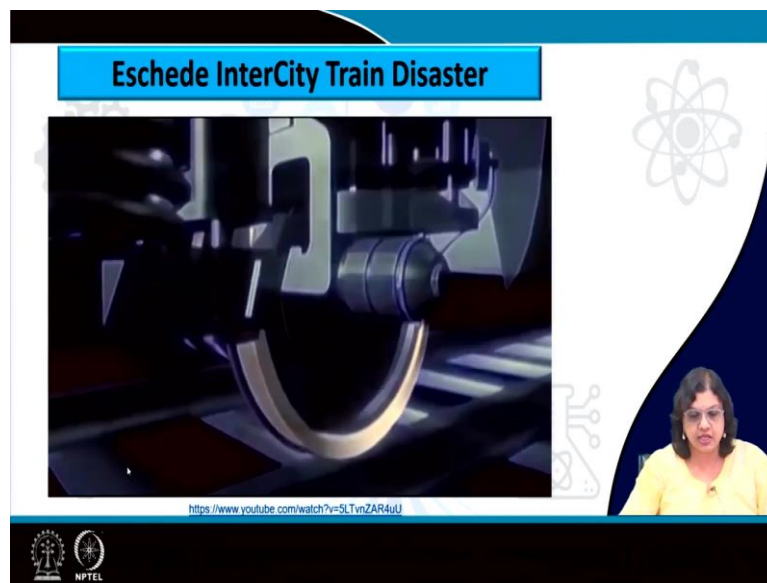
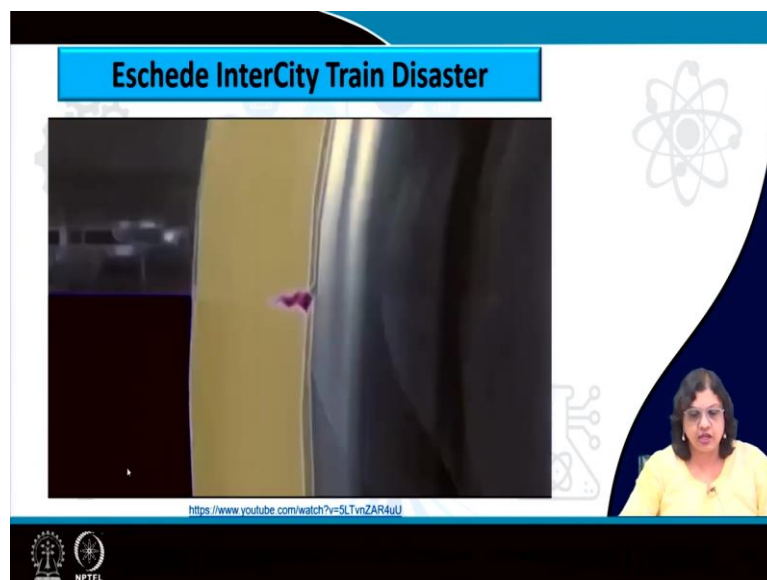
And here is video to understand what actually has happened. As you can see that while it was traveling at certain speed, this crack moved forward, it broke and then it just penetrated through the floor. And while it was moving at some particular track as it was thrown on the sideways that made it actually hit the bridge. As you can see that it is moving sideways and here comes the bridge which just got hit by the 4th wagon onward as it moves sideways. And you can see how the entire bridge collapsed based on that and suddenly the wagons are also being affected and as we have seen in the pictures they have been just stacked like a pile of cards.

So, this is a simulated one based on the actual reason for failure and you can see that this is such a catastrophic event.
