**Fracture, Fatigue and Failures of Materials**  
**Professor Indrani Sen**  
**Department of Metallurgical and Material Engineering**  
**Indian Institute of Technology Kharagpur**  
**Lecture 59**  
**Failure Analysis – Case Study – Columbia**

## Space Shuttle Columbia

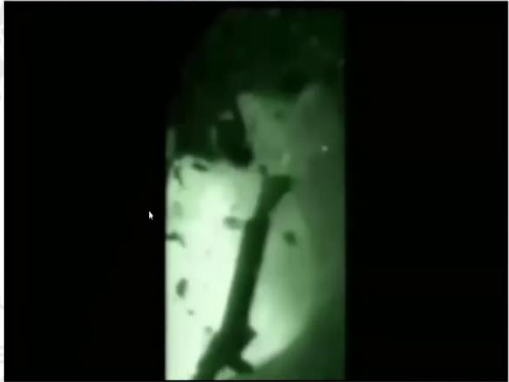
Now this has been repeated in the simulation for you to understand more and you can see the same frame was actually being shown that how it is, so this part is a simulation one. To understand that what kind of force it might have generated, how much the damage are there and what is the size of the hole that has been formed that has been very very carefully analysed and determined and experimentally validated as well.

So, this has been shown from different angles for you to understand that what is actually the impact of the foam falling on the left wing of the aircraft. So, the spacecraft however has performed all it is intended to do and everything looked quite successful up to that level and nobody was actually aware that something has happened to the structure and now you can see that the point the time at which it was supposed to land, at that point there are has been just some fragments which has been noted on the skyline.
